## URBAN FORESTRY ASSOCIATES, INC.

### ARBORIST REPORT

*Douglas Fir Tree #1 Rincon Ridge Park 2016*

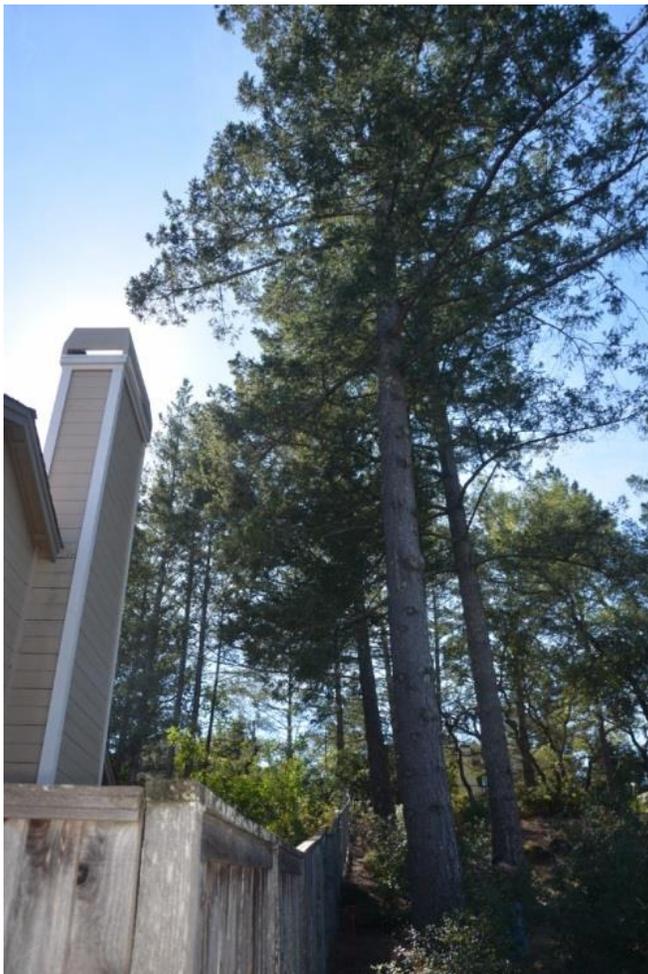
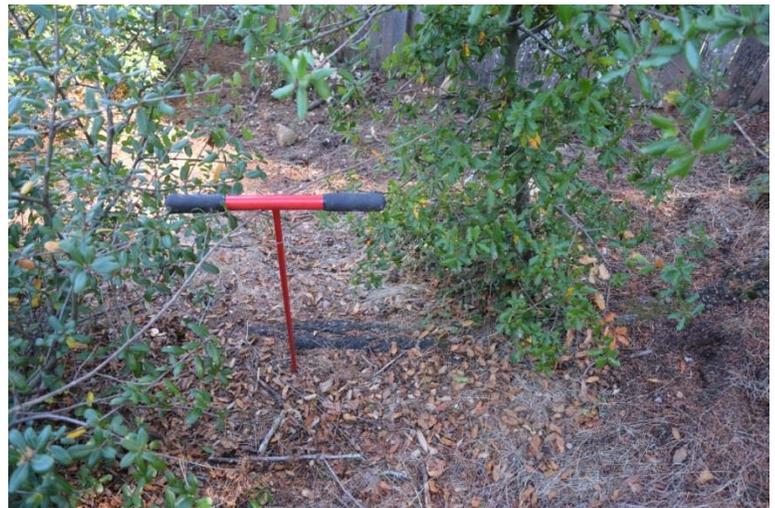
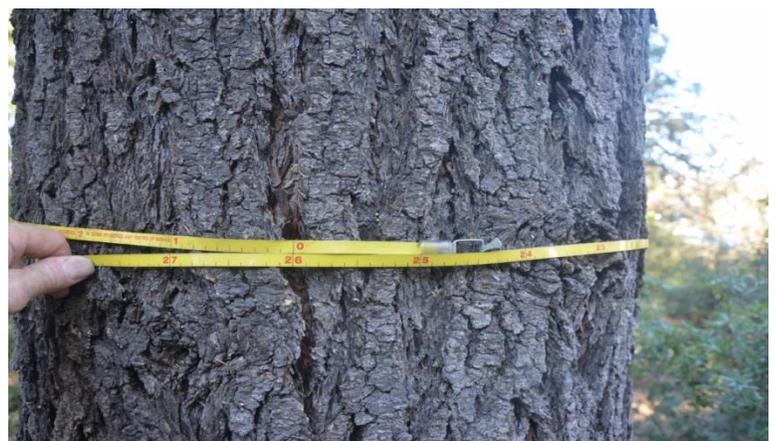
Species Douglas Fir (*Pseudotsuga menziesii*)  
Size 26.0" DBH<sup>1</sup> Height = 72.5'  
Location Along the east fence line / common property line between the Park and 3912 Park Garden Dr.  
Condition This tree is the lowest fir on the slope along the property line. It is adjacent to the fireplace chimney the east base of the tree is 6 feet from a 3 foot deep cut for the 3912 Park Garden Drive house pad. The prevailing winds and the storm winds out of the Gulf of Alaska come out of the west northwest. In response to wind loads conifer trees produce and rely on "compression roots" on the lee side of the tree for stability. Major compression roots had to have been cut in the excavation of the house pad and installation of the retaining wall. Probing of the roots on the windward side of the tree discovered soil voids under the lateral (roots See Photo Figure 1).  
Conclusion Given the location of the tree near a home, the poor root environment, the root disturbance during construction and evidence that the root plate has been lifting under wind loads (voids), I concluded that this tree has an unacceptable risk of failure onto a target of great value.

Photo Figure 1 – Tree #1 targets the adjacent home and has been destabilized by species characteristics, the site soil conditions and the home construction impacts. Soil voids associated with lateral roots were found.

**RECOM'D Remove – This tree is an unacceptable risk to people and property.**
