ARBORIST REPORT

Douglas Fir Tree 2 Rincon Ridge Park 2016

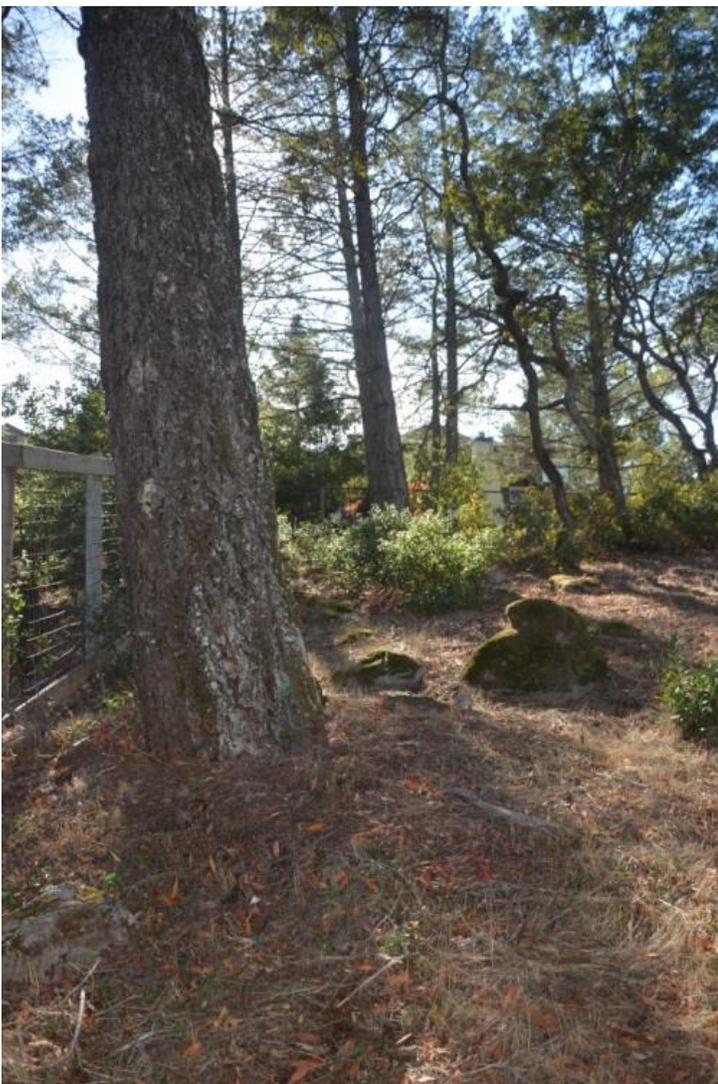
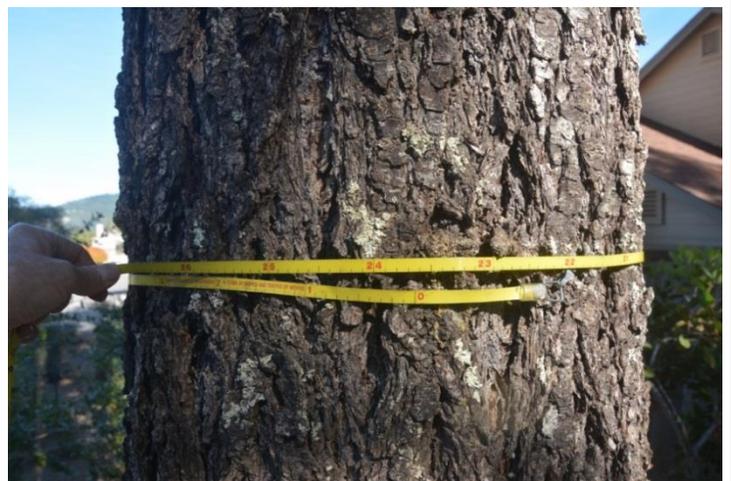
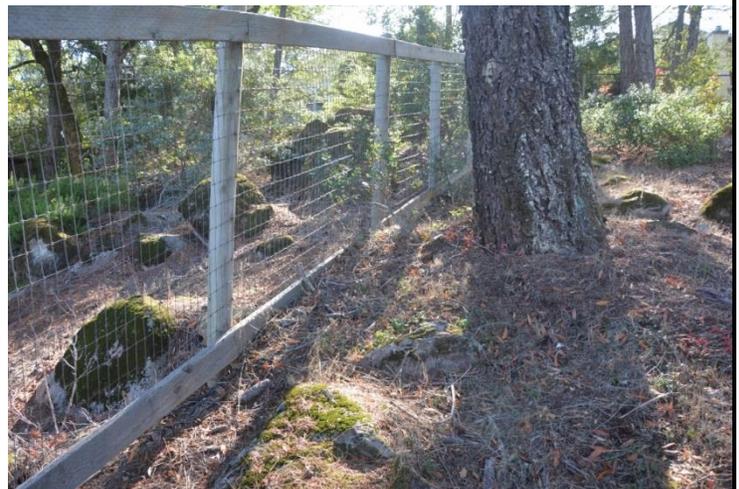
Species Douglas Fir (*Pseudotsuga menziesii*)
Size 23.6" DBH¹ Height = 71 feet
Location Up slope long the east fence line / common property line between the park fir grove and 3912 Park Garden Drive and 3825 Sedgewoore Drive.
Condition This tree is at the top of the slope along the south property line. It is adjacent to the fence. It has an asymmetric canopy balance toward 3929 and 3925 Sedgewoore Drive. It is in decline and the canopy is sparsely foliated (See Photo Figure 1). The soils are extremely shallow, discontinuous and rocky with little space for root penetration and anchorage.
Conclusion Given the location of the tree near two homes, the poor root environment and drought decline, I have concluded that this tree has an unacceptable risk of failure onto targets of high value.

Photo Figure 1 – Tree #2 targets the adjacent homes at 3925 and 3929 Sedgewoore Drive and has been stressed by poor soils and the drought.

It is destabilized by species characteristics, the site soil conditions and drought decline.

RECOM'D Remove – This tree is an unacceptable risk to people and property.
