ARBORIST REPORT For Douglas Fir Tree 7 Rincon Ridge Park 2016

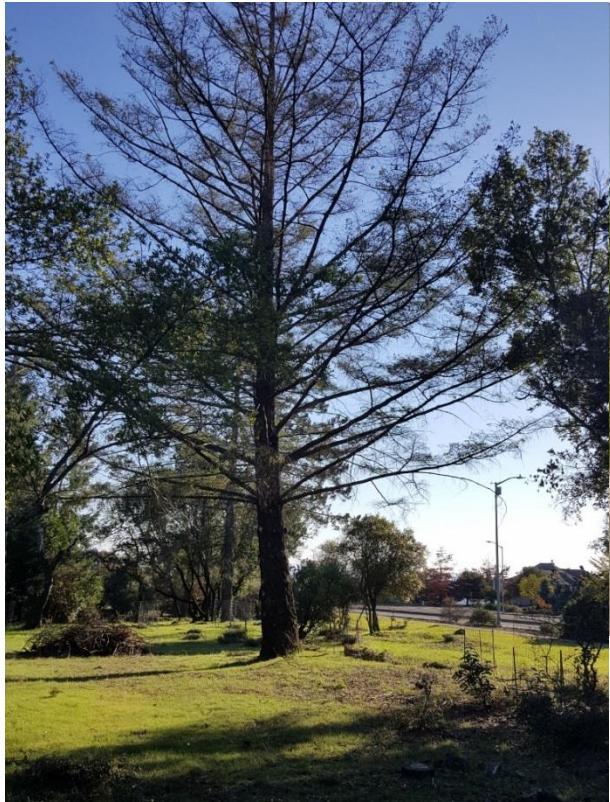
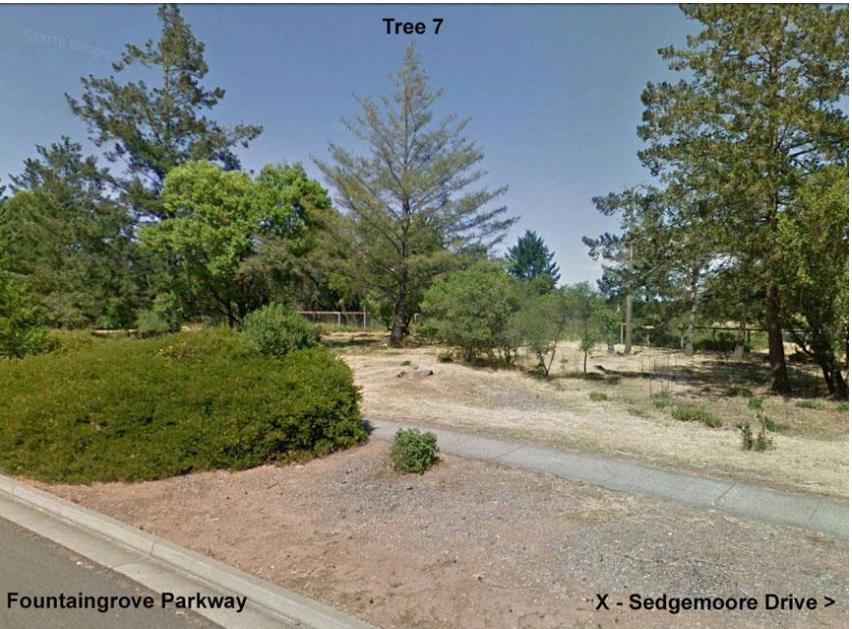
Species Douglas Fir (*Pseudotsuga menziesii*)
Size 27.7" DBH¹ Height = 61.5 feet
Location In the southwest corner of the park behind 3901 Sedgemoore Drive and by the enclosure gate.
Condition This tree is now senescent (irreversible decline) with almost no living foliage (See Photo Figure 1). It is full of fine deadwood and the live fuel moisture must also be very low.
Conclusion This tree will not recover and is a fire hazard.

Photo Figure 1 – Tree 7 is dying from drought stress. It is a fire hazard due to its species characteristics, the xeric site soil conditions and drought decline.

RECOM'D Remove – This tree is an unacceptable fire risk.
