ARBORIST REPORT

Black Oak Hybrid leaning over 3758 & 3762 Hadley Hill Road Property's

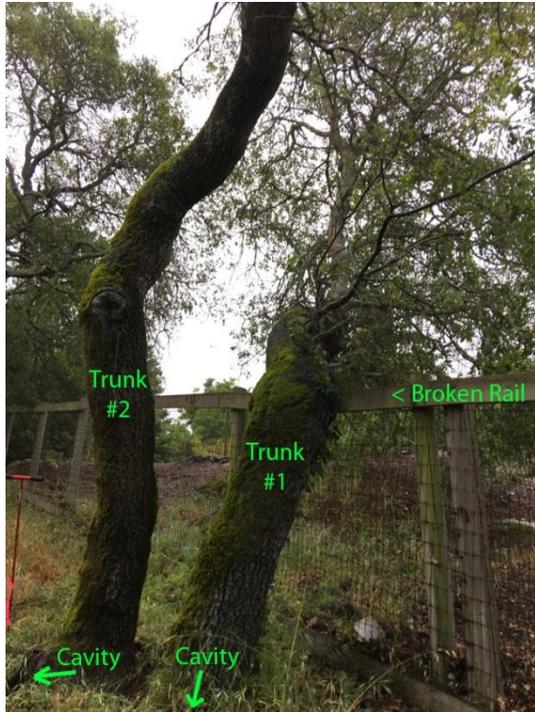
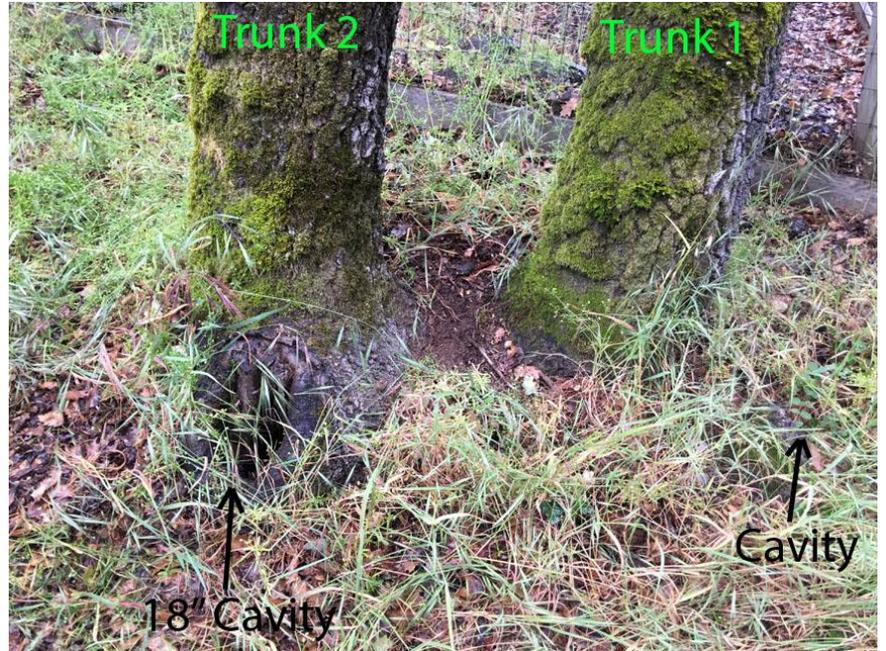
Species	Black Oak Hybrid (<i>Quercus kelloggii</i> X <i>Q. Agrifolia</i>)
Size	18.1" DBH – Possibly two trunks of the same tree attached below grade.
Location	Leans over fence at 3758 Hadley Hill Fountaingrove II OSMA
Condition	This tree has a severe, unstable lean over the 3758 fence. It has moved recently and has damaged the high fence rail. Small voids were found through soil probing supporting the conclusion of recent movement. Within 6" of base of another hybrid oak trunk with a second spar to it that is now hollow and rotted out. The concern is that the leaning trunk has crossing roots in competition under the ground with the second more upright trunk. The decay opening in the base of the second trunk revealed a decayed base. The cavity extends 18 inches under the second trunk.
Conclusions	The leaning trunk is in the process of failure onto private property. The target area is rated "low". The target area is a low use area and the risk to people is low. However, its total failure would destroy the section of fence it leans on and open the 3758 yard to deer predation. The more upright trunk is heavily decayed and should also be removed.

Tree #1 – T-1 is structurally unstable and in the process of failure.

Recom'd	Remove both trunks to abate the failure of the leaning trunk and the second trunk.

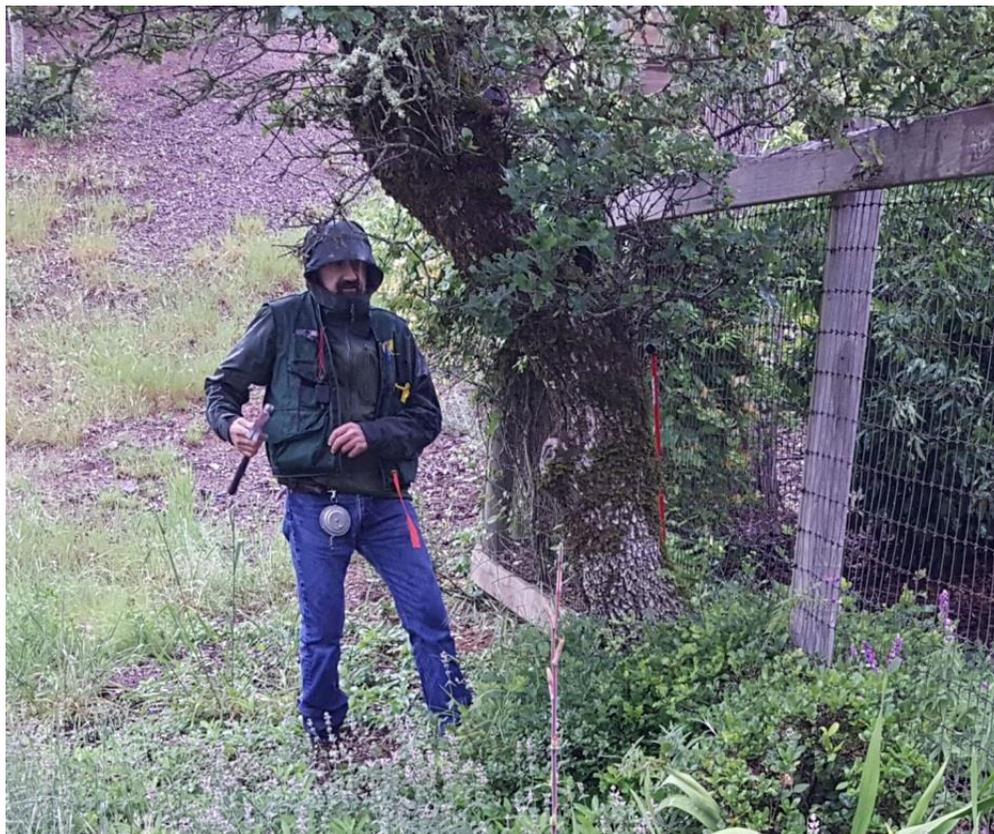
Species	Oregon Oak (<i>c.f. Quercus garryana</i>)
Size	9.5" DBH class
Location	Line tree between 3758 Hadley Hill Drive and Fountaingrove II OSMA It is growing in the fence line and damaging the fence.
Condition	This tree is growing in the fence line separating the private property at 3762 Hadley Hill Drive. and OSMA land. It appears to be either a second growth stem from a mature tree that was removed many years ago to build the fence or an escaped stem form a shrub-like clump of shoots suppressed for many years by deer browse until the breath of the bushy shoots released

Tree #2 – The Oregon white oak growing in the fence may well be second growth from a tree that was removed years ago to install the fence. It is now disrupting the fence and should be removed and the stump killed to prevent future damage and deer access.

Remove: Given the nature of the mature stem and subordinate sprouts, the stem and the basal sprouts must be removed or chemically treated to kill the sprouts and the root system to prevent future disruption of the fence.
